Nondestructive Evaluation of Four Sister Bridges in Virginia Using Manual NDE Technologies and Robotic Platform RABIT

Final Report
July 2015

Nenad Gucunski
Professor

Rutgers' Center for Advanced Infrastructure and Transportation
100 Brett Road
Piscataway, NJ 08854

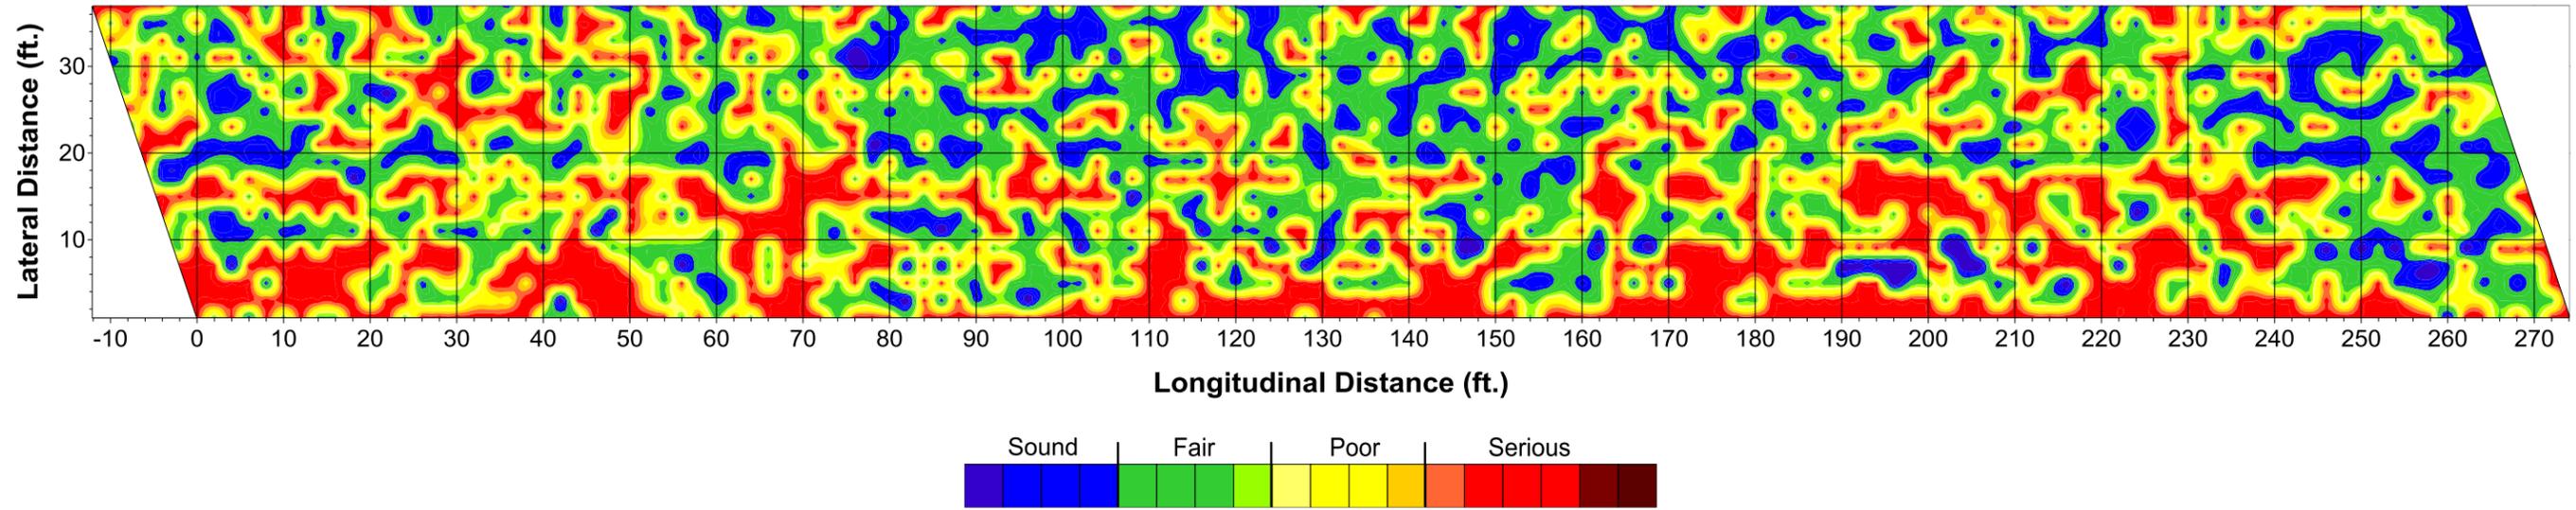
Figure 1. Delamination condition map of bridge no. 00000000014178

Survey Method	Condition Rating	Distribution (%)			
		Good	Fair	Poor	Serious
Manual	39.9	21	31	7	41

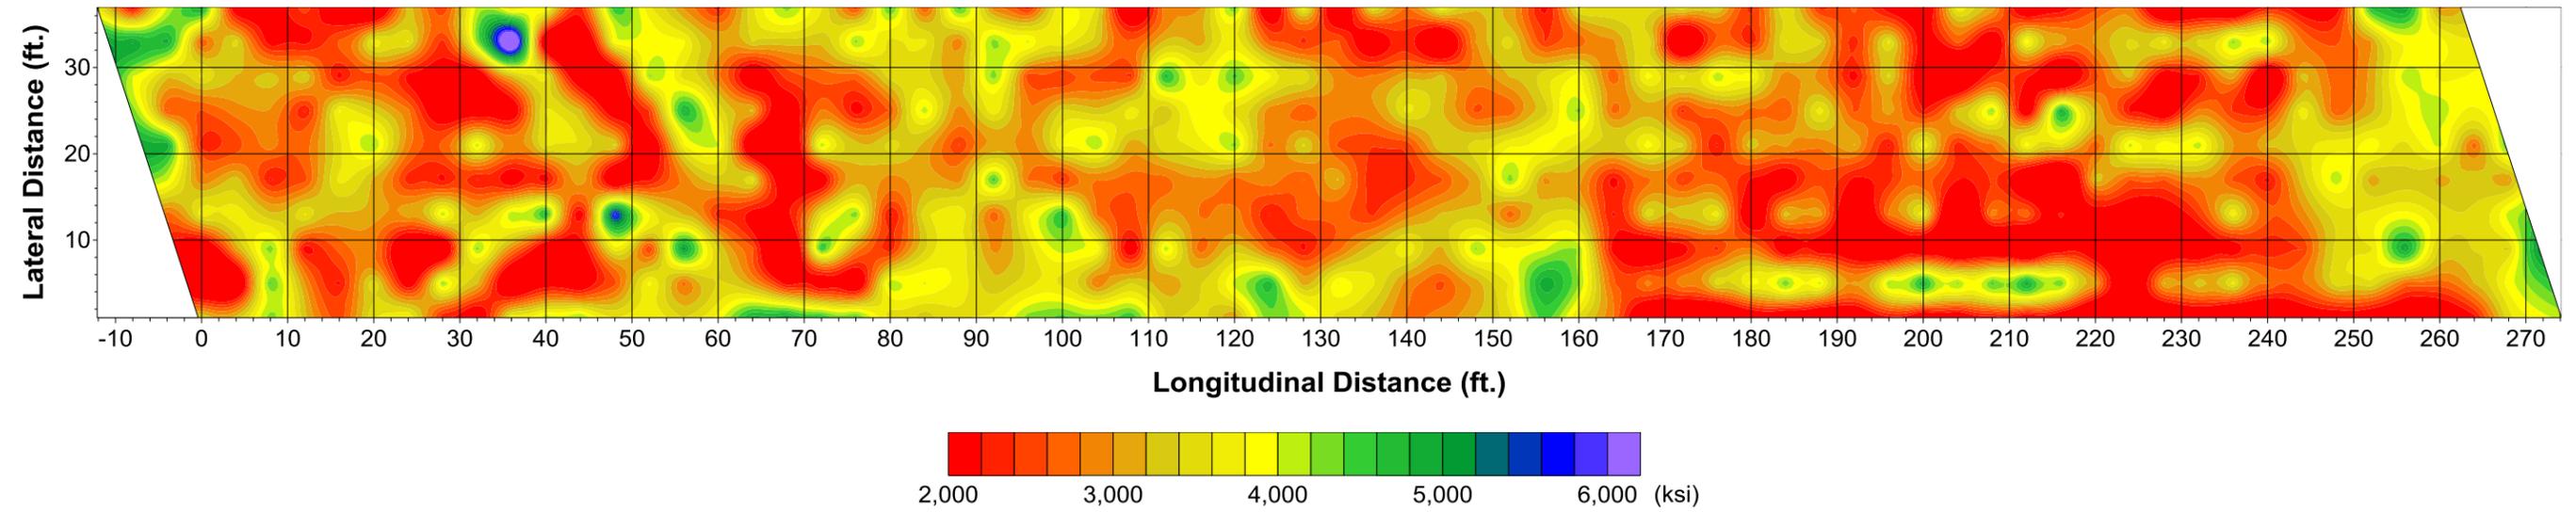
Figure 2. Concrete modulus map of bridge no. 00000000014178

Survey Method	Distribution (%)			Mean <i>E</i> (ksi)	Standard Deviation (ksi)
	< 3,500 ksi	3,500 - 4,500 ksi	> 4,500 ksi		
Manual	68	27	5	3,008	988

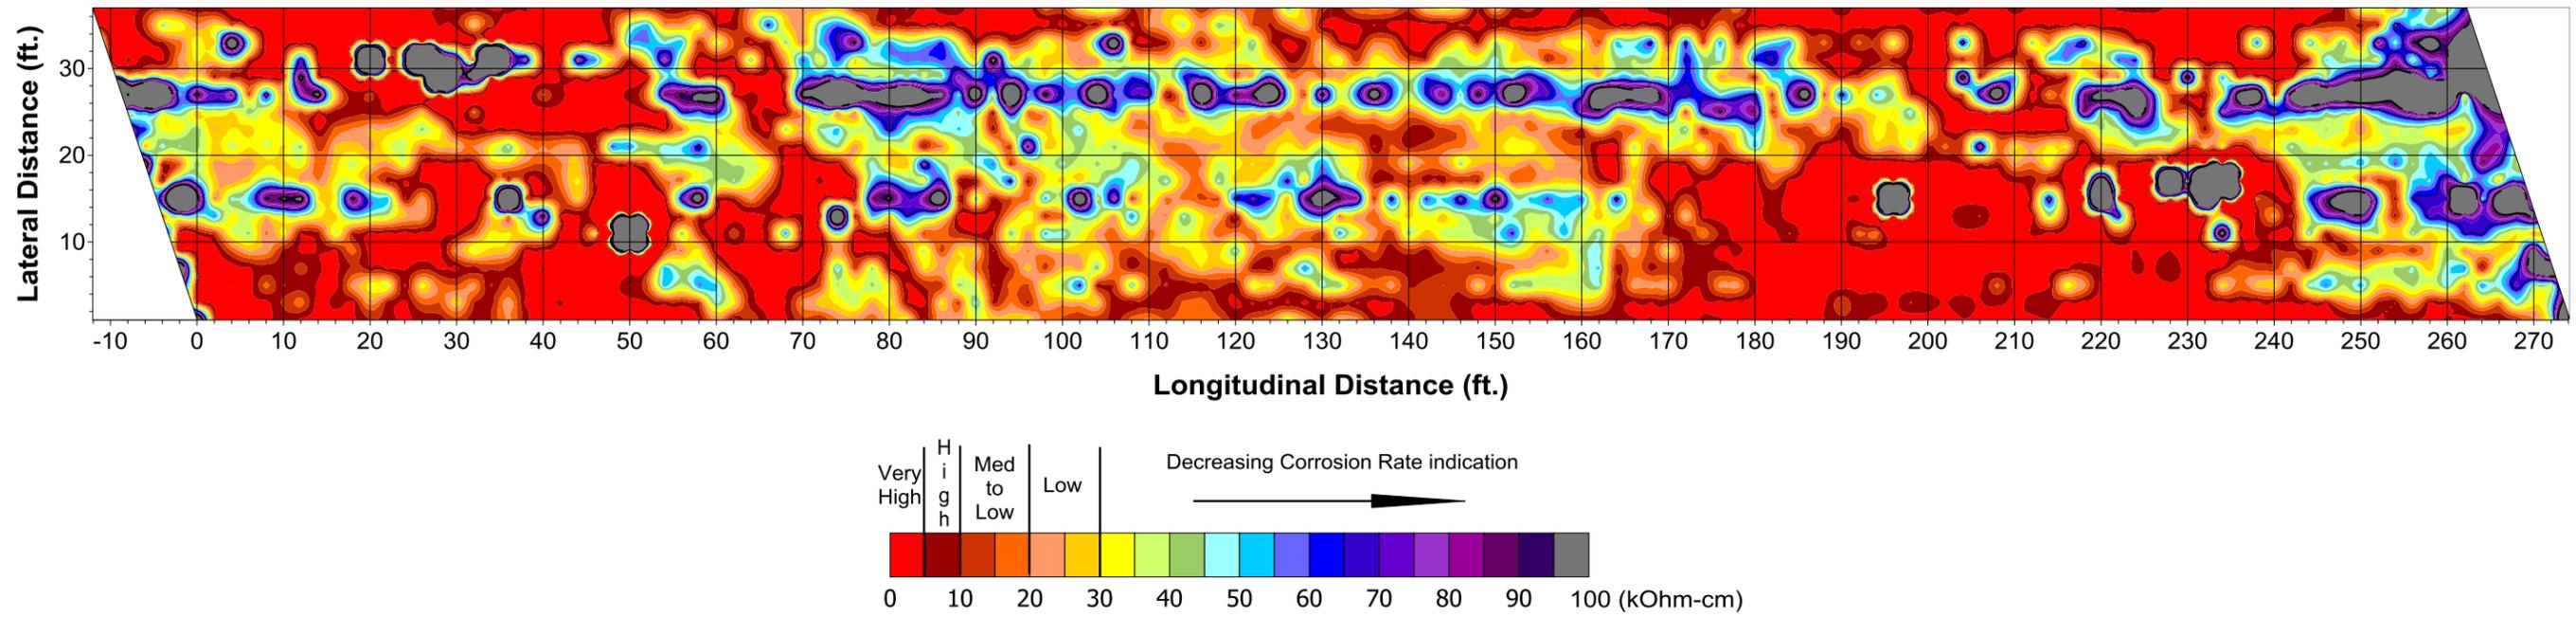
Figure 3. Map of electrical resistivity and expected corrosion rates of bridge no. 00000000014178

Survey Method	Condition Rating	Distribution (%)			
		High	Moderate	Low	Very Low
Manual	40.9	44	17	17	22

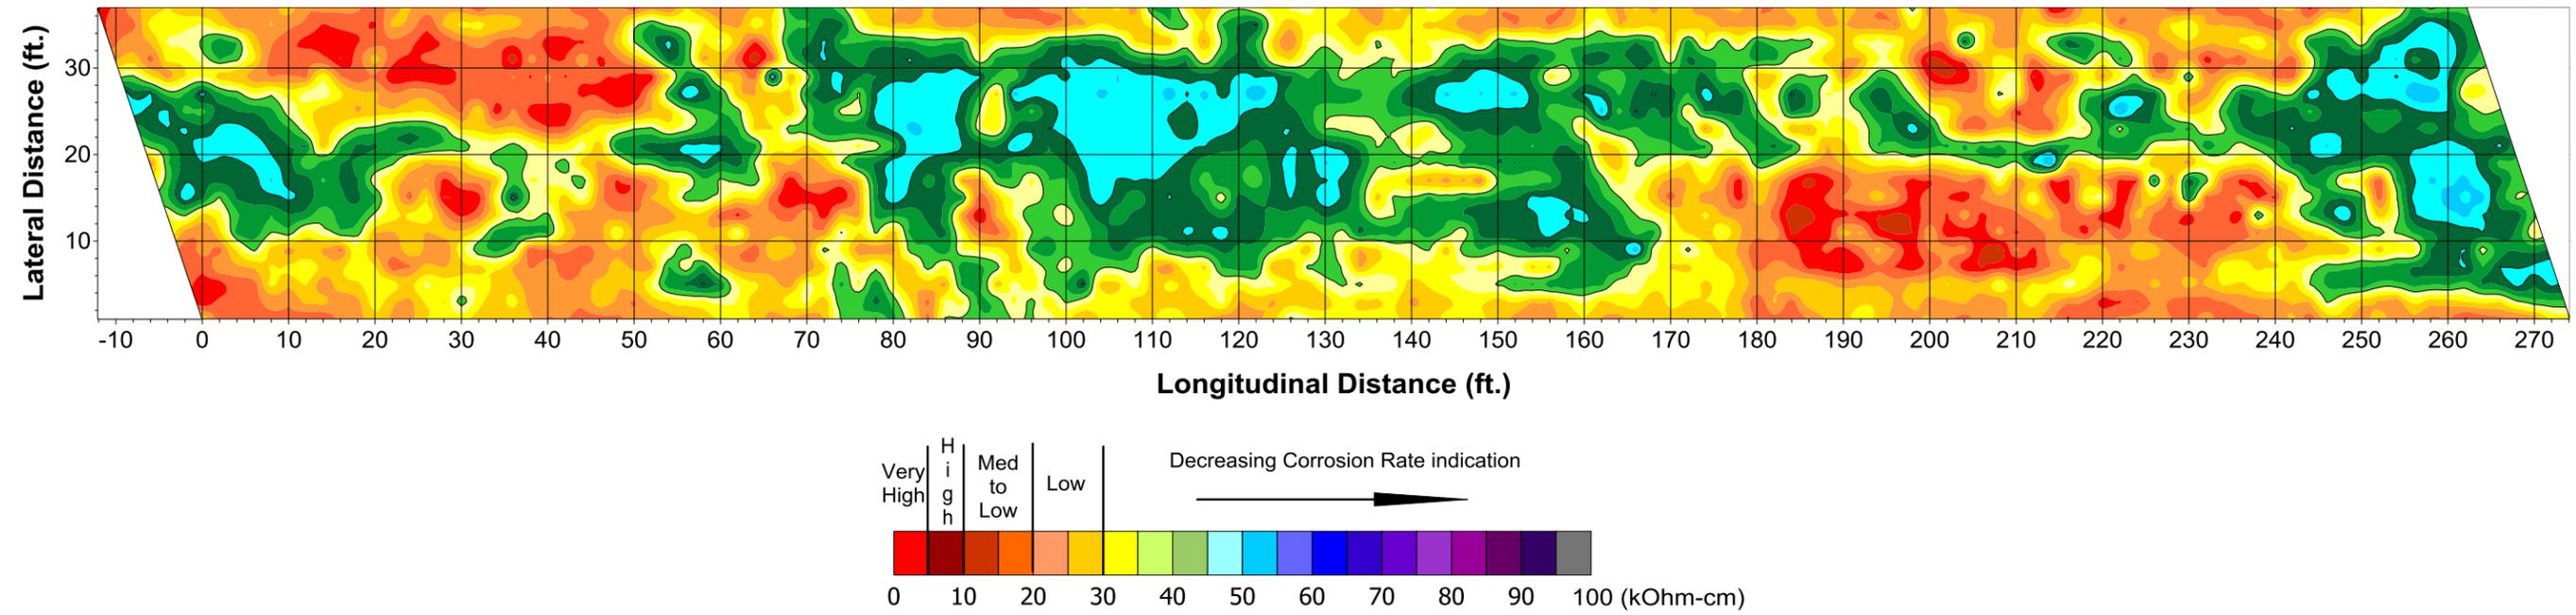
Figure 4. Map of potential and expected corrosion activity of bridge no. 000000000014178

Condition Rating	Distribution (%)		
	90% Probability of Corrosion	Transition	90% Probability of No Corrosion
23.7	60	32	8

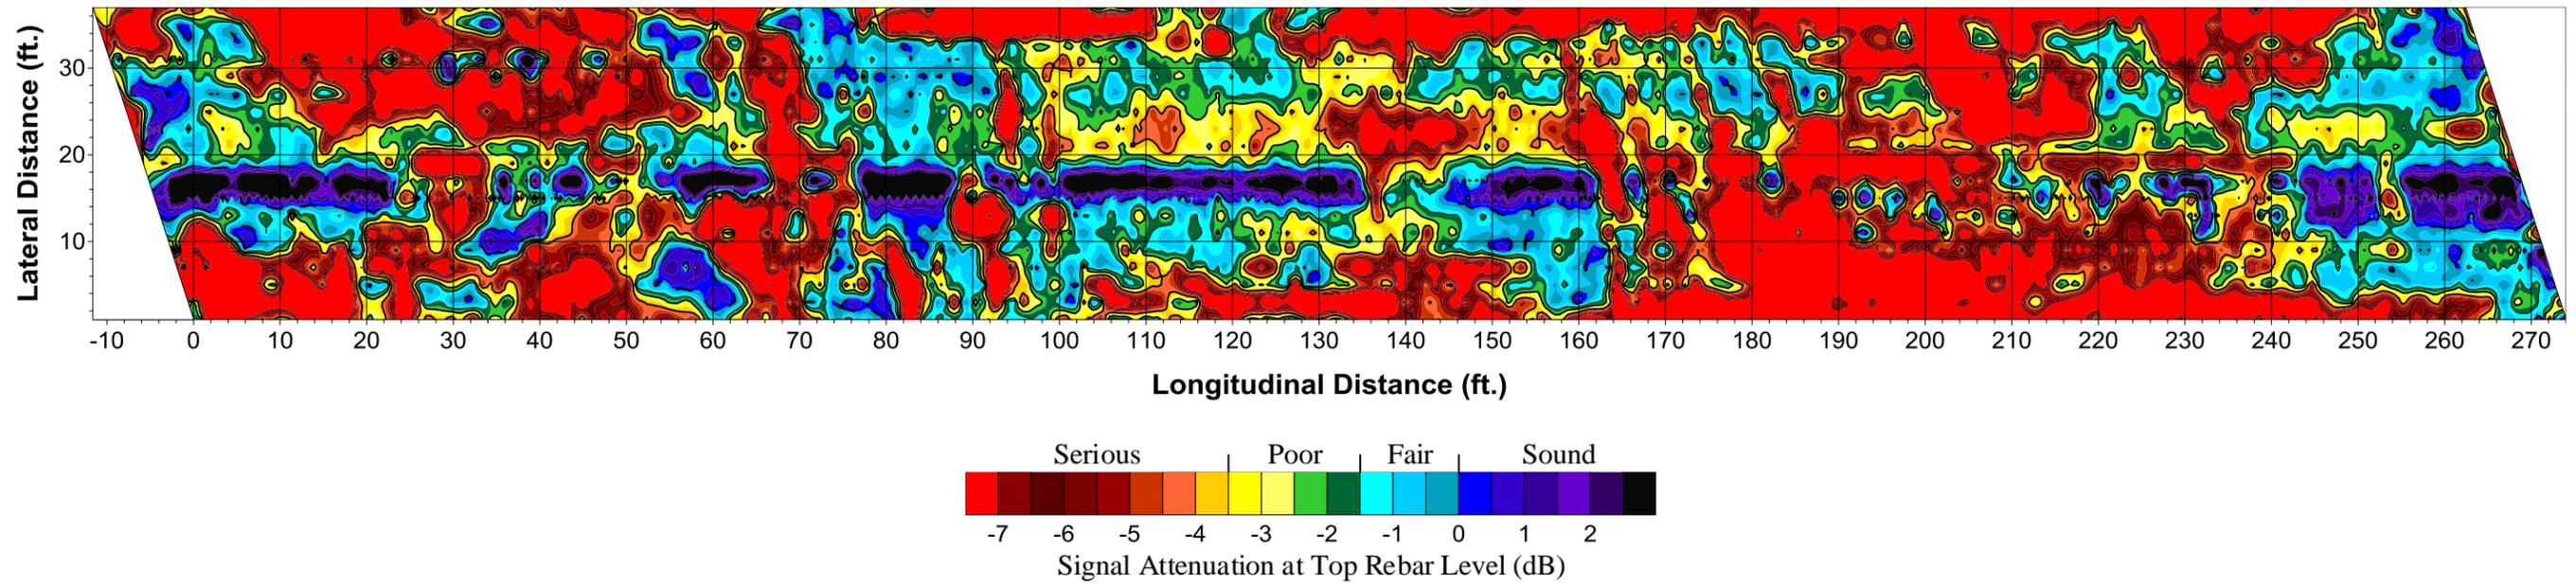
Figure 5. Map of signal attenuation and deck condition of bridge no. 00000000014178

Survey Method	Condition Rating	Distribution (%)			
		Good	Fair	Poor	Serious
Manual	33.4	11	19	22	48

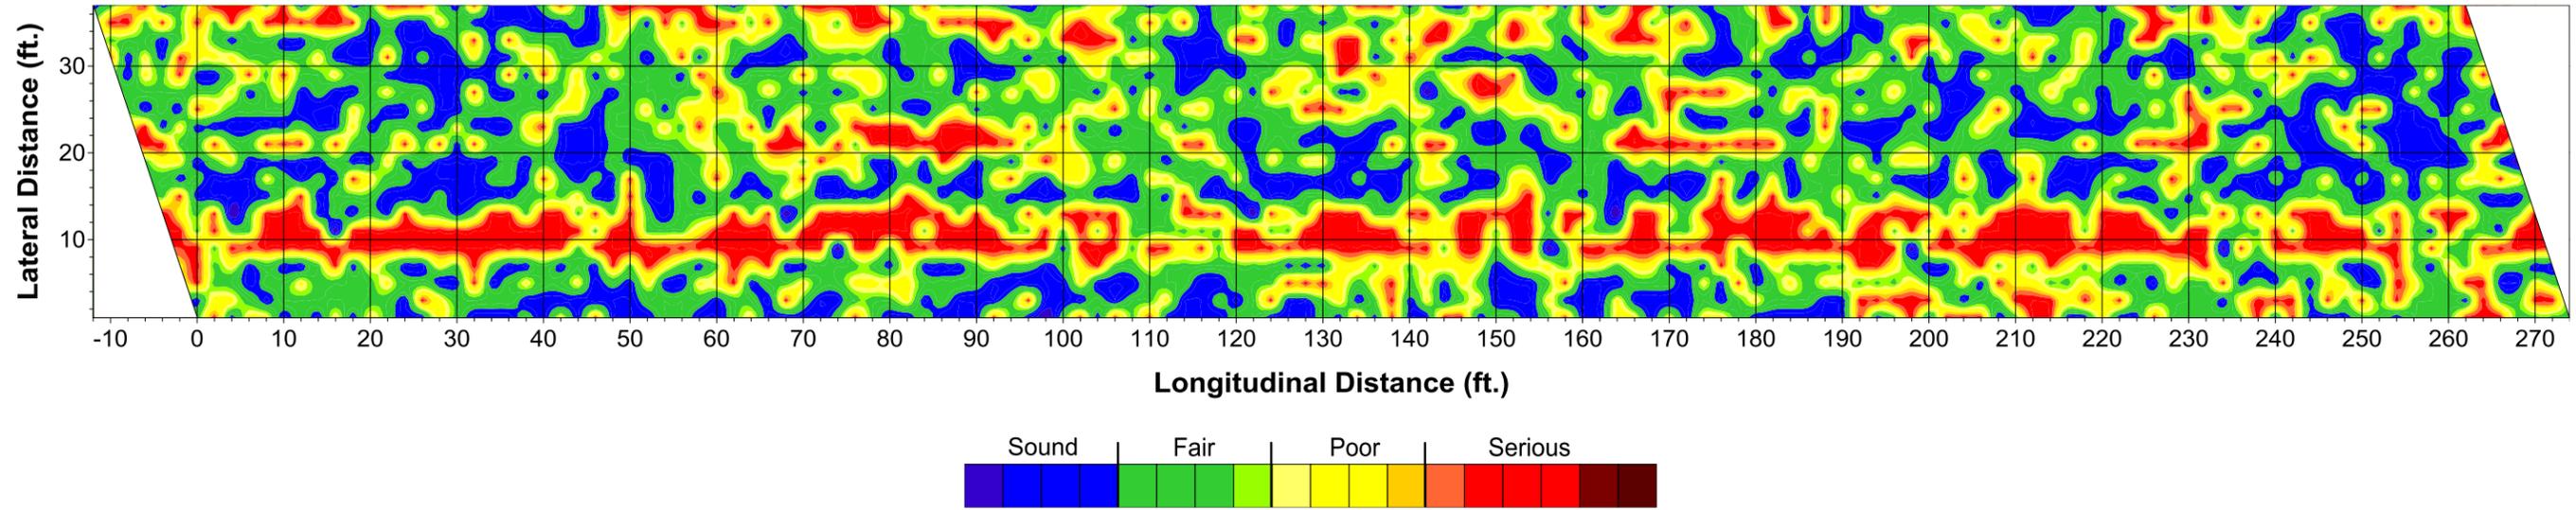
Figure 6. Delamination condition map of bridge no. 00000000014180

Survey Method	Condition Rating	Distribution (%)			
		Good	Fair	Poor	Serious
Manual	52.1	28	34	14	24

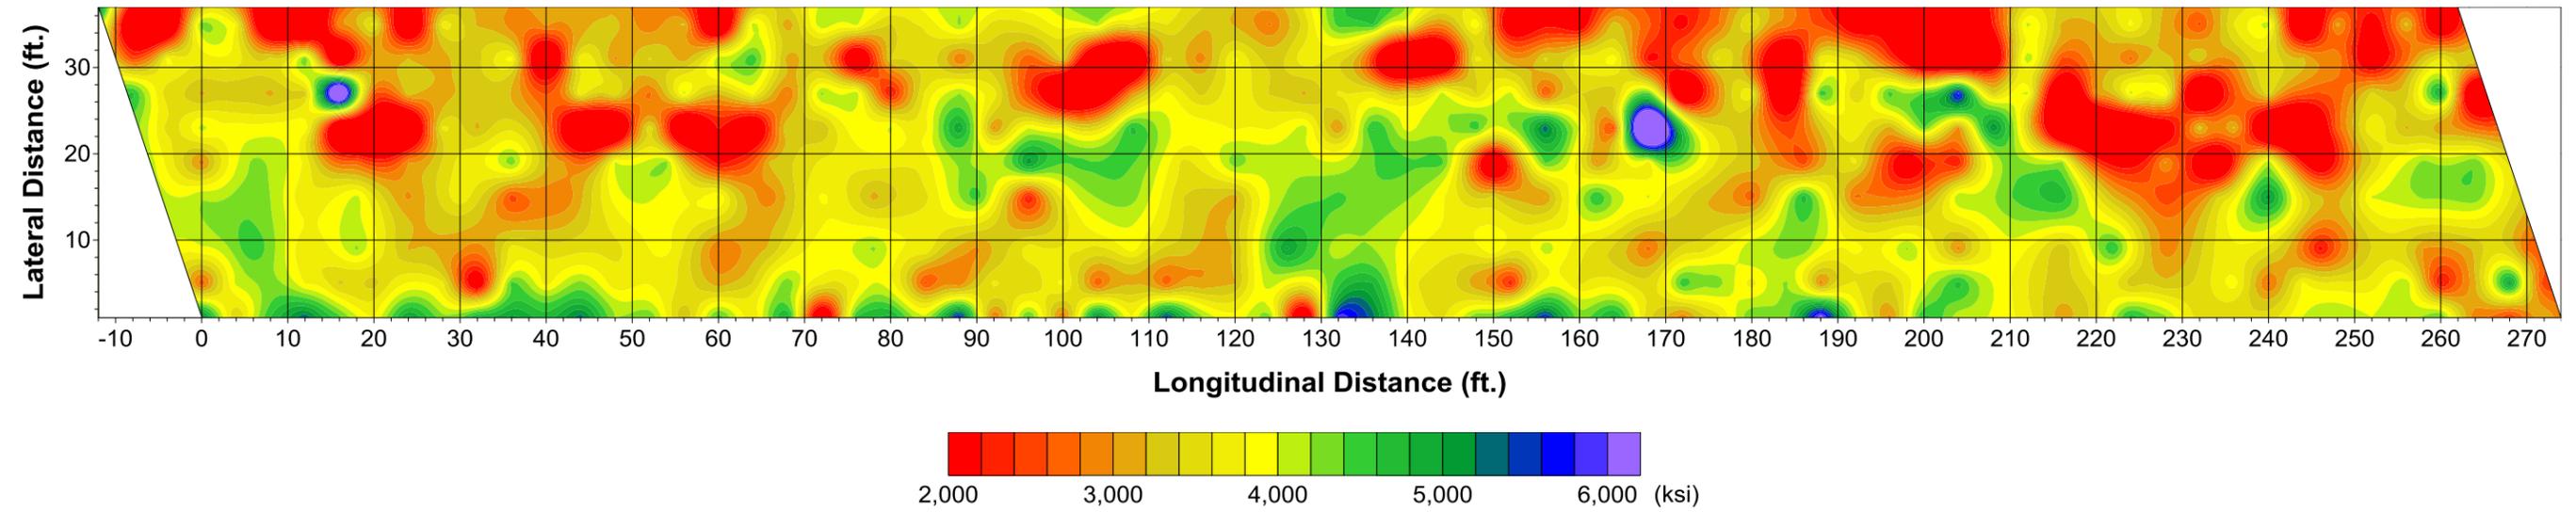
Figure 7. Concrete modulus map of bridge no. 00000000014180

Survey Method	Distribution (%)			Mean E (ksi)	Standard Deviation (ksi)
	< 3,500 ksi	3,500 - 4,500 ksi	> 4,500 ksi		
Manual	48	41	11	3,514	1,582

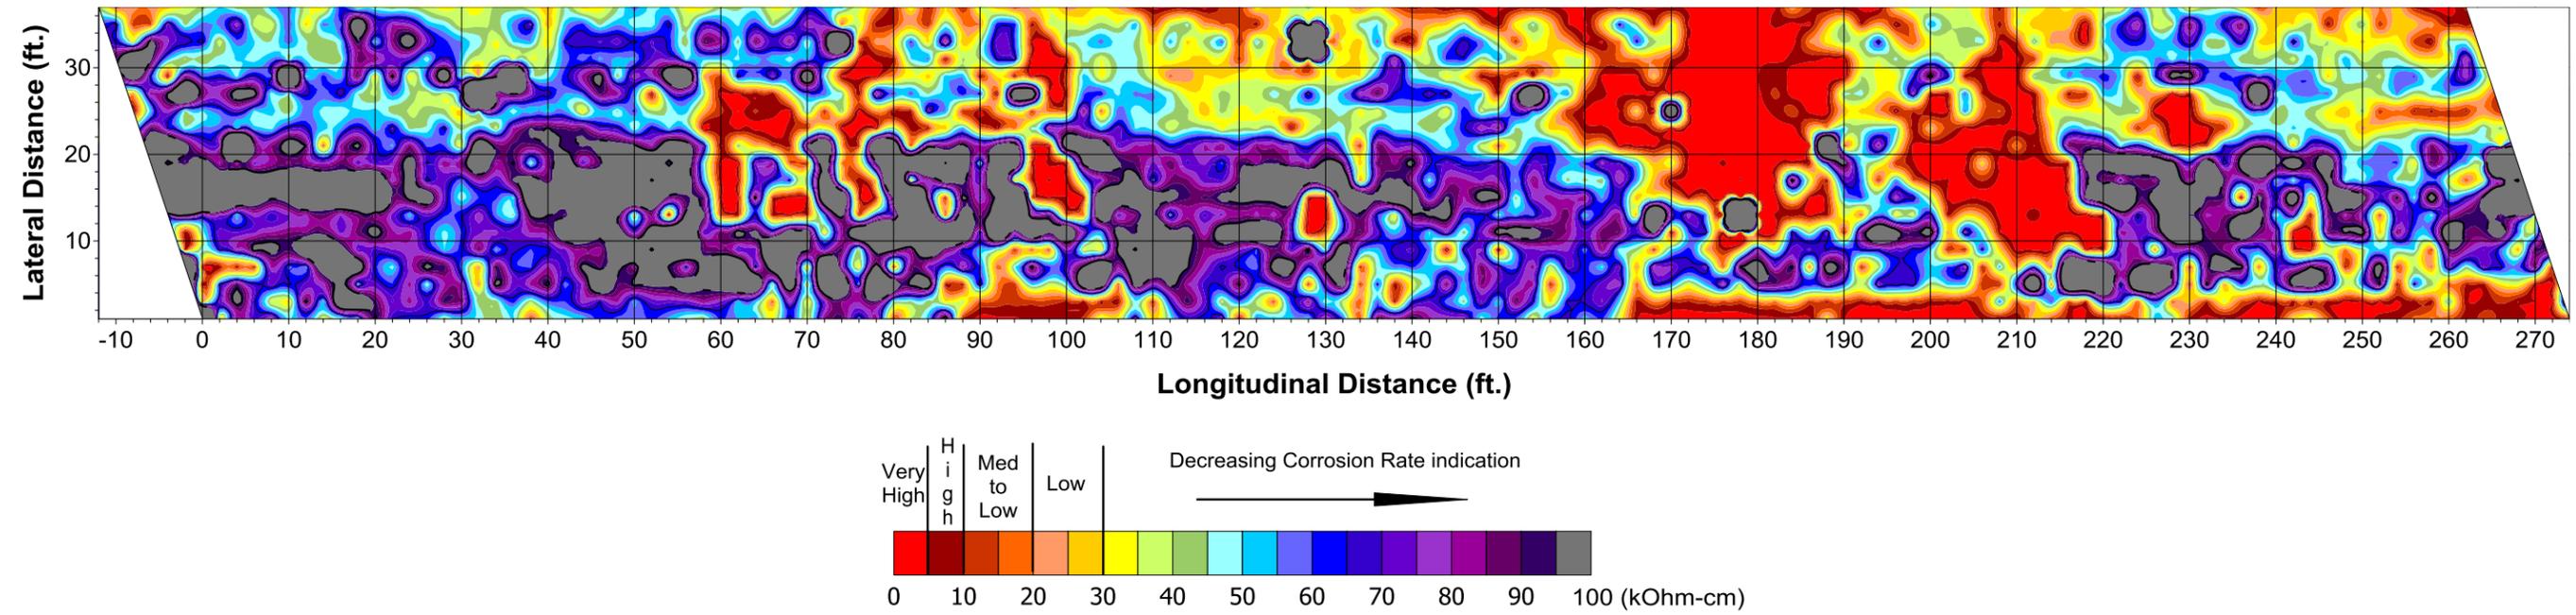
Figure 8. Map of electrical resistivity and expected corrosion rates of bridge no. 00000000014180

Survey Method	Condition Rating	Distribution (%)			
		High	Moderate	Low	Very Low
Manual	72.1	20	8	12	61

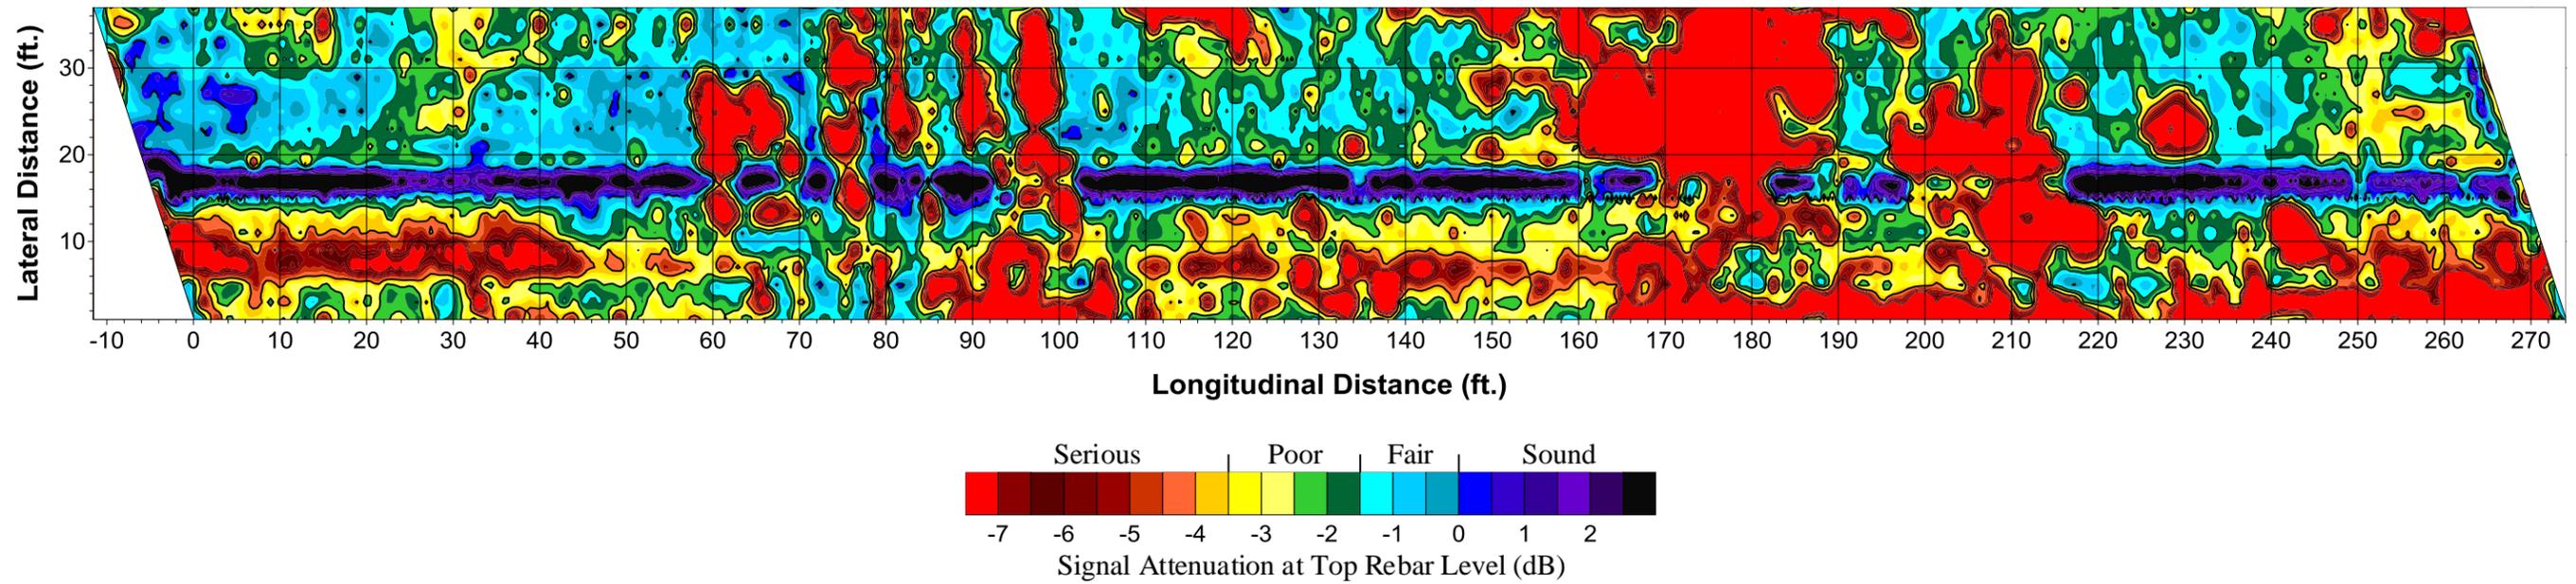
Figure 9. Map of signal attenuation and deck condition of bridge no. 00000000014180

Survey Method	Condition Rating	Distribution (%)			
		Good	Fair	Poor	Serious
Manual	40.6	12	22	33	33

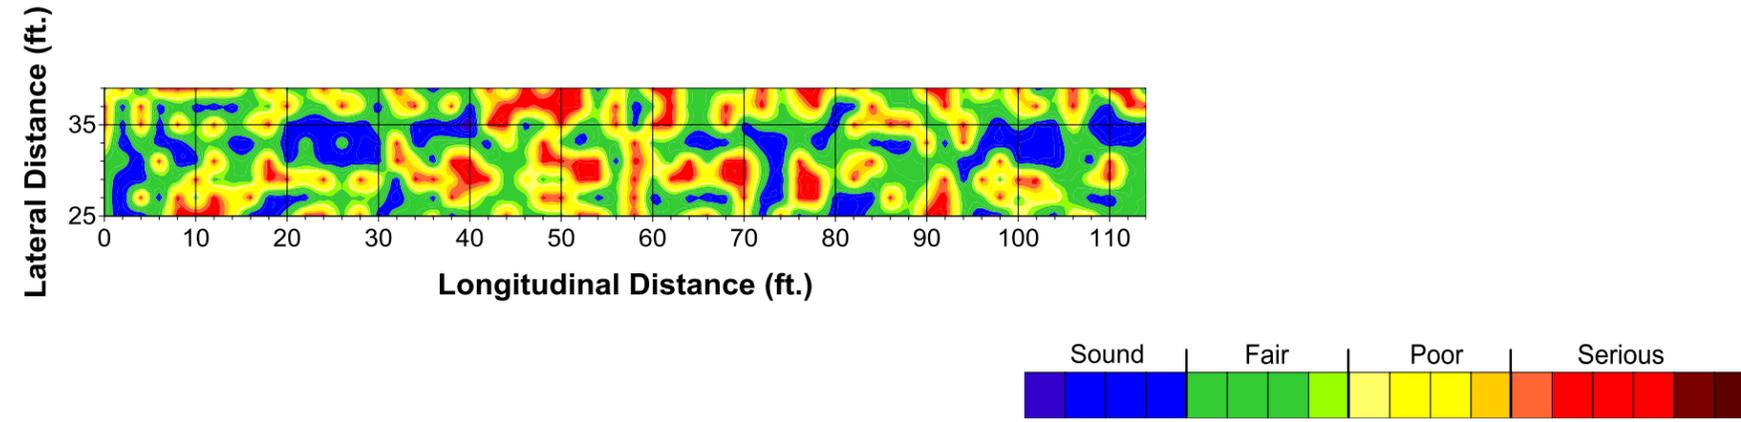
Figure 10. Delamination condition map of bridge no. 00000000014216

Survey Method	Condition Rating	Distribution (%)			
		Good	Fair	Poor	Serious
Manual	47.9	26	36	8	30

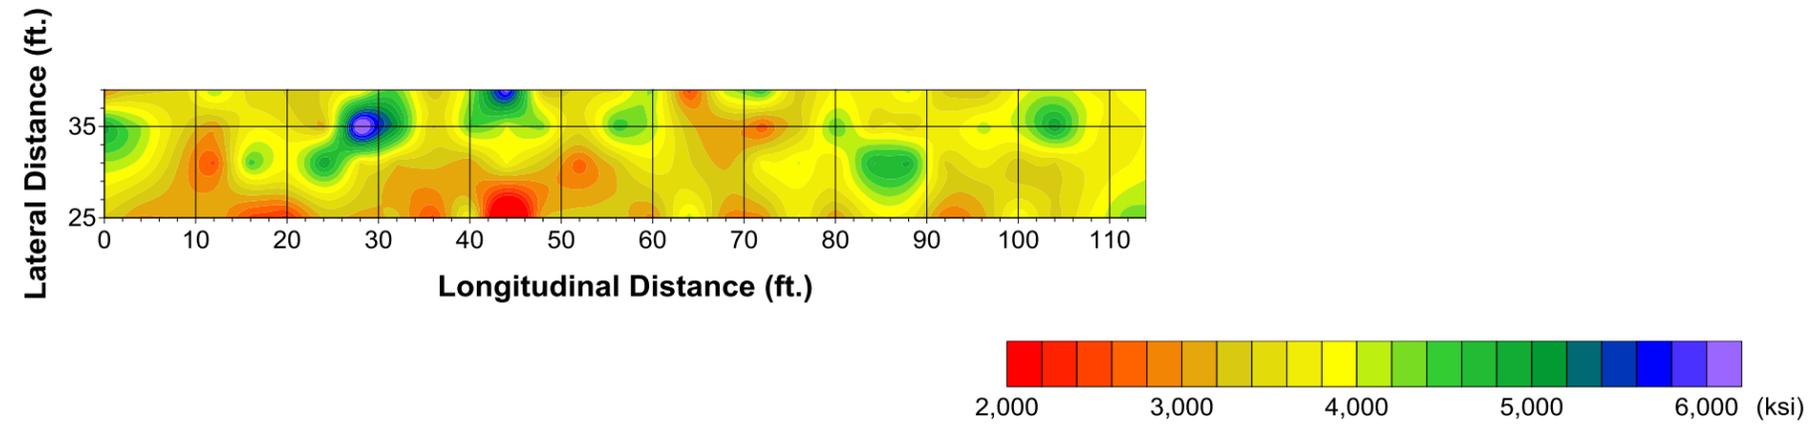
Figure 11. Concrete modulus map of bridge no. 000000000014216

Survey Method	Distribution (%)			Mean <i>E</i> (ksi)	Standard Deviation (ksi)
	< 3,500 ksi	3,500 - 4,500 ksi	> 4,500 ksi		
Manual	50	41	10	3,625	764

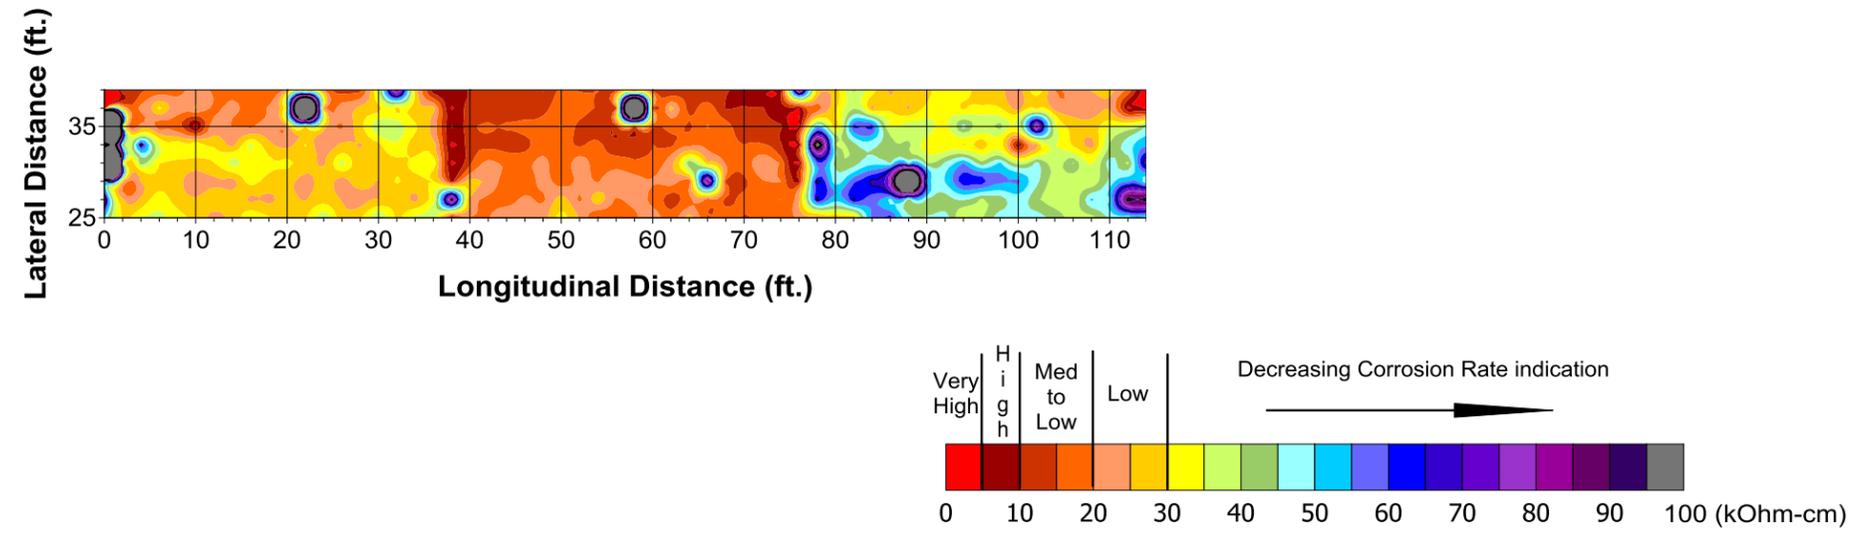
Figure 12. Map of electrical resistivity and expected corrosion rates of bridge no. 00000000014216

Survey Method	Condition Rating	Distribution (%)			
		High	Moderate	Low	Very Low
Manual	59.0	6	43	31	20

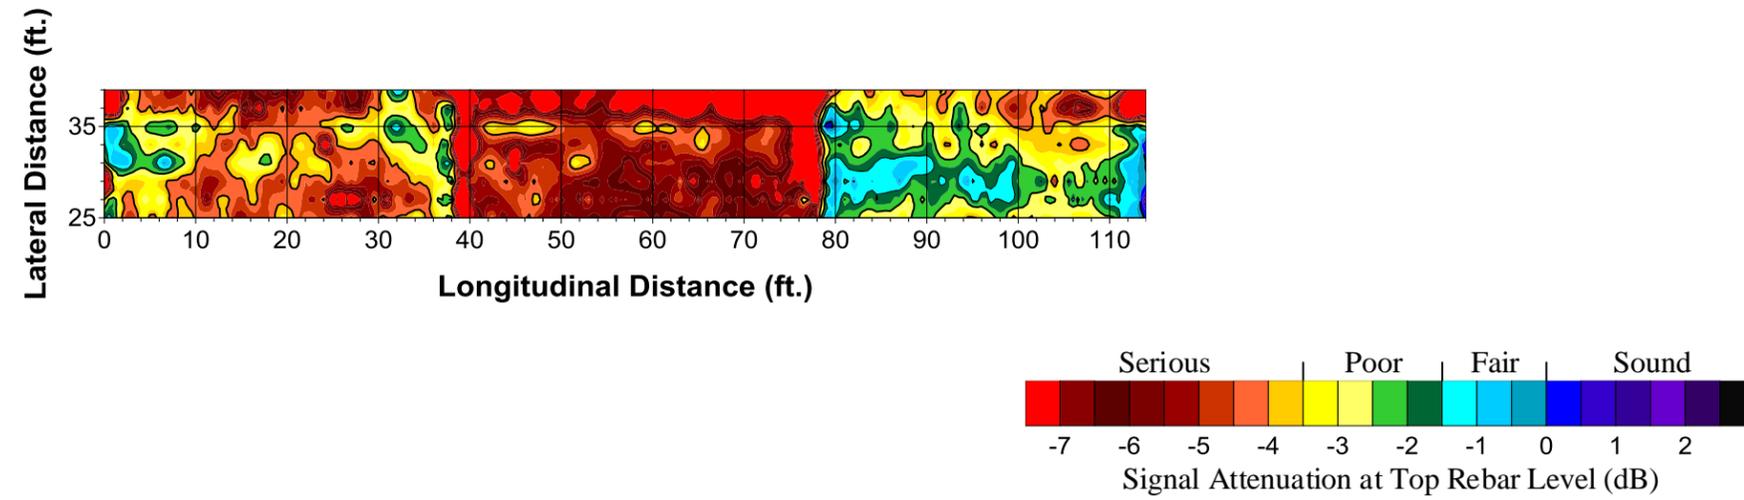
Figure 13. Map of signal attenuation and deck condition of bridge no. 00000000014216

Survey Method	Condition Rating	Distribution (%)			
		Good	Fair	Poor	Serious
Manual	15.8	1	7	26	67

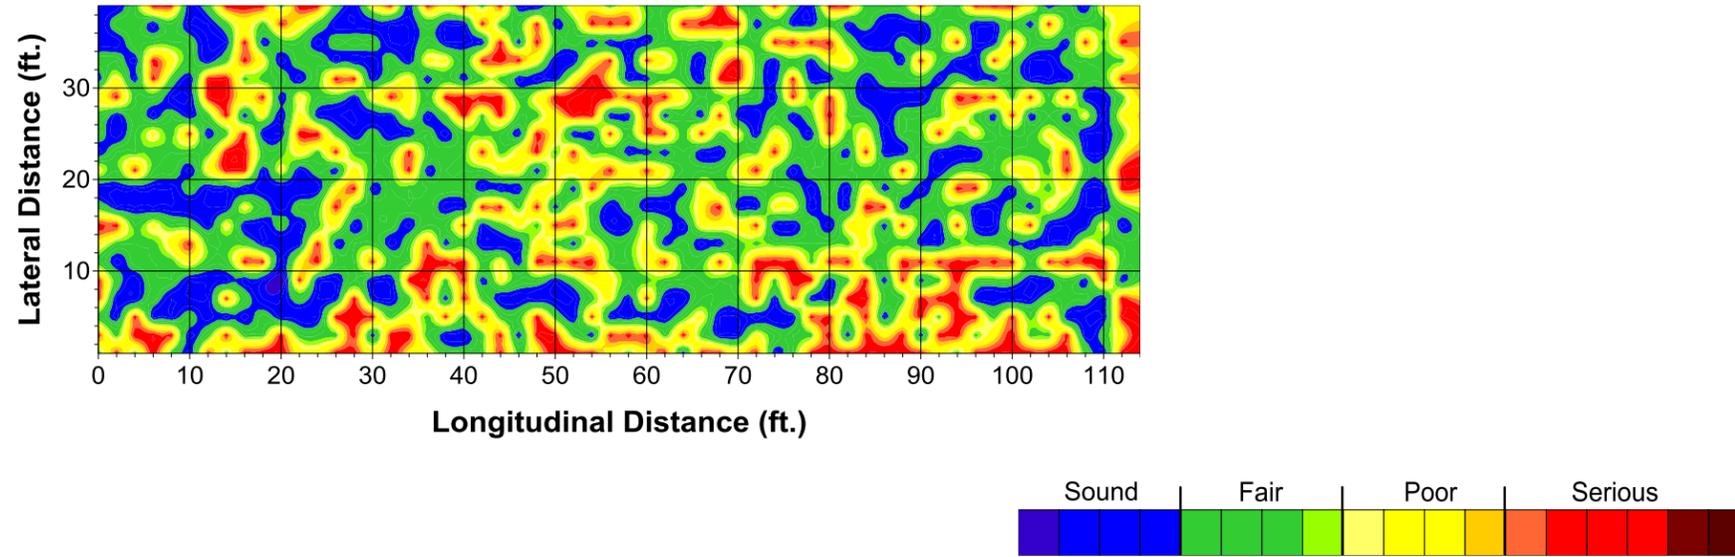
Figure 14. Delamination condition map of bridge no. 00000000014218

Survey Method	Condition Rating	Distribution (%)			
		Good	Fair	Poor	Serious
Manual	53.1	30	35	11	24

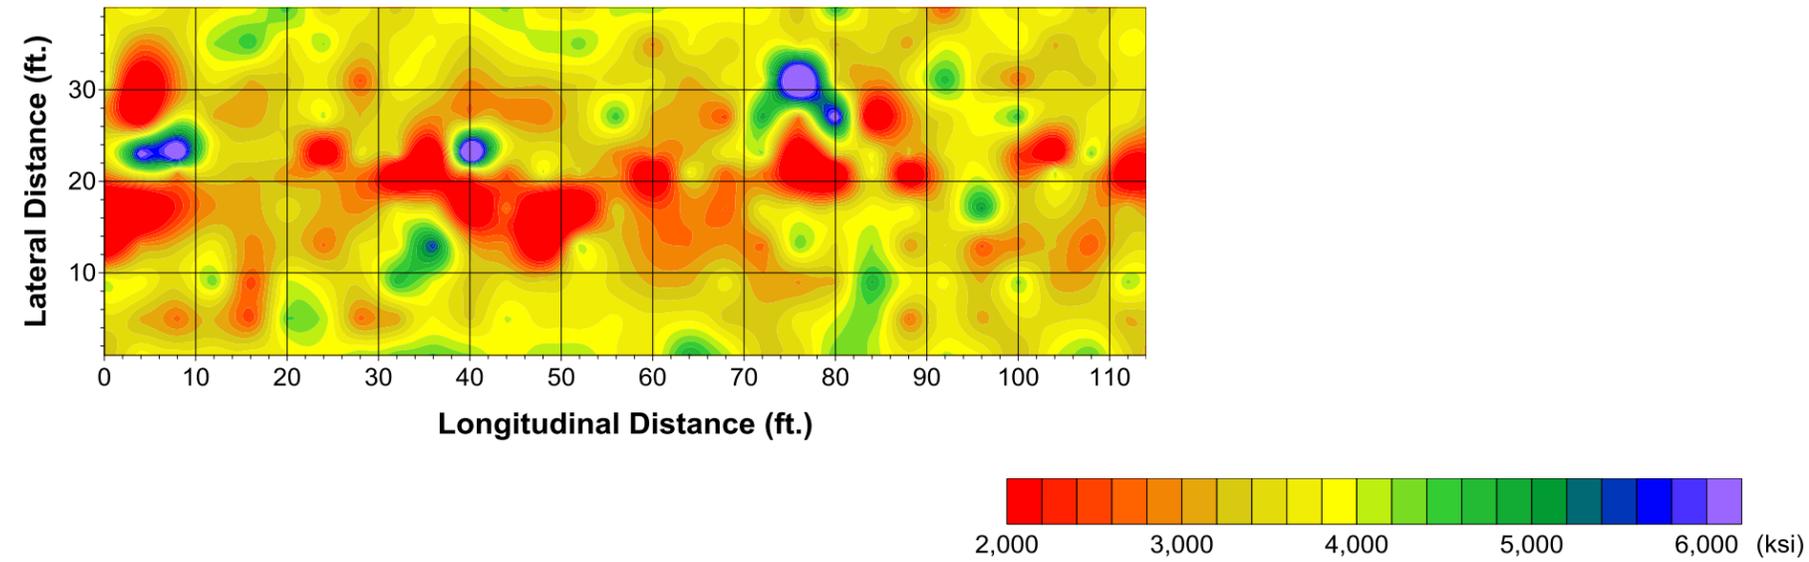
Figure 15. Concrete modulus map of bridge no. 00000000014218

Survey Method	Distribution (%)			Mean E (ksi)	Standard Deviation (ksi)
	< 3,500 ksi	3,500 - 4,500 ksi	> 4,500 ksi		
Manual	48	45	6	3,638	1,016

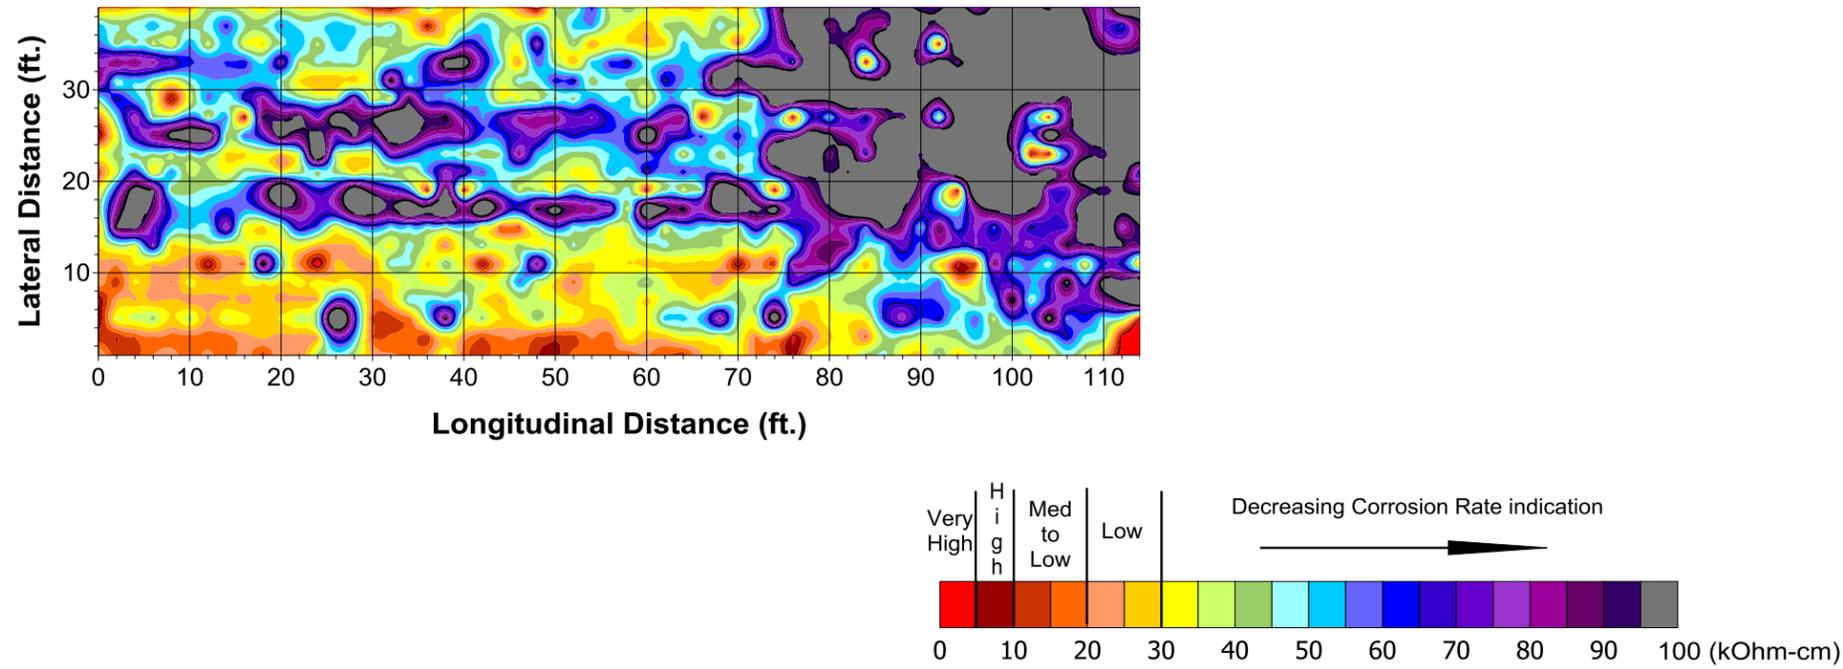
Figure 16. Map of electrical resistivity and expected corrosion rates of bridge no. 00000000014218

Survey Method	Condition Rating	Distribution (%)			
		High	Moderate	Low	Very Low
Manual	82.2	4	12	24	61

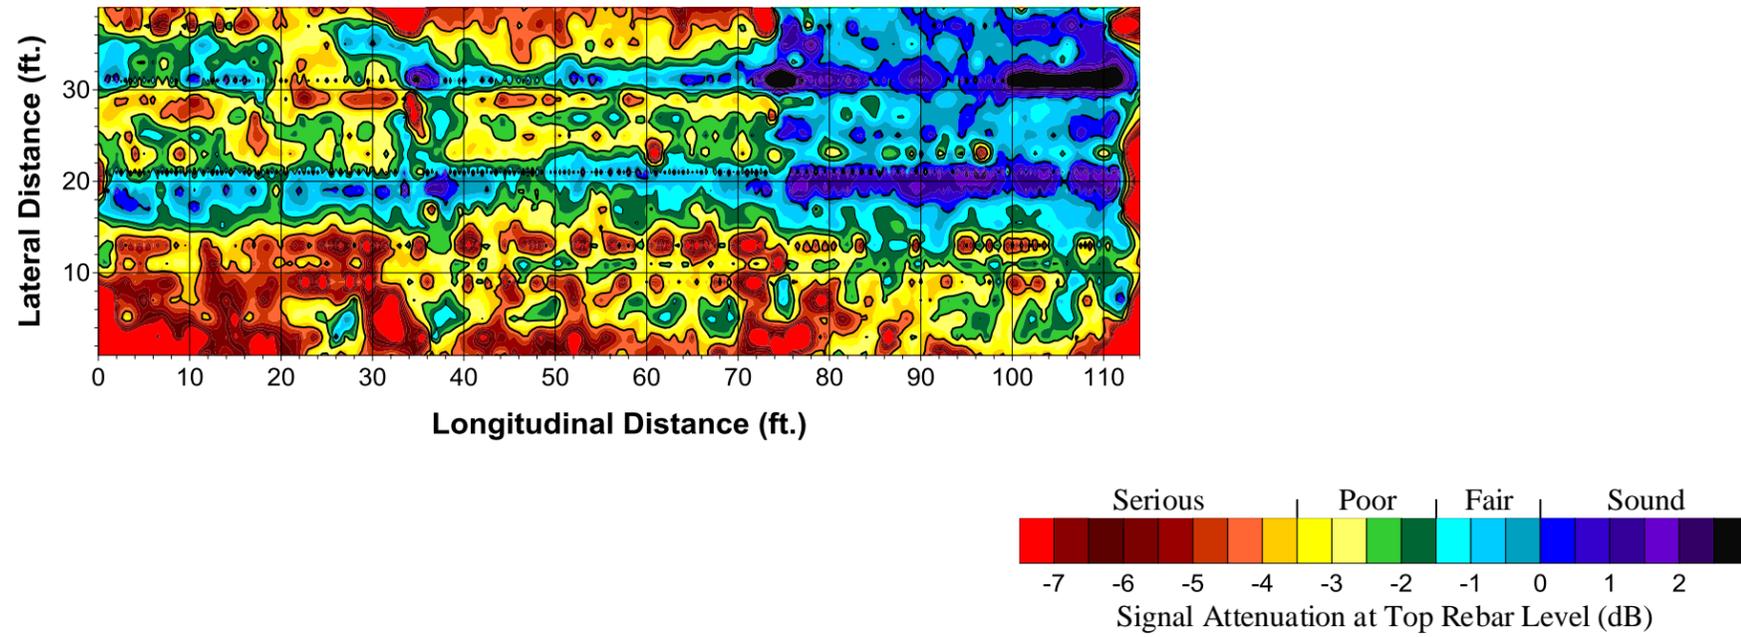
Figure 17. Map of signal attenuation and deck condition of bridge no. 00000000014218

Survey Method	Condition Rating	Distribution (%)			
		Good	Fair	Poor	Serious
Manual	40.3	14	18	36	33
